## Memphremagog South Bay Access

### **South Bay:** Coventry Street Access

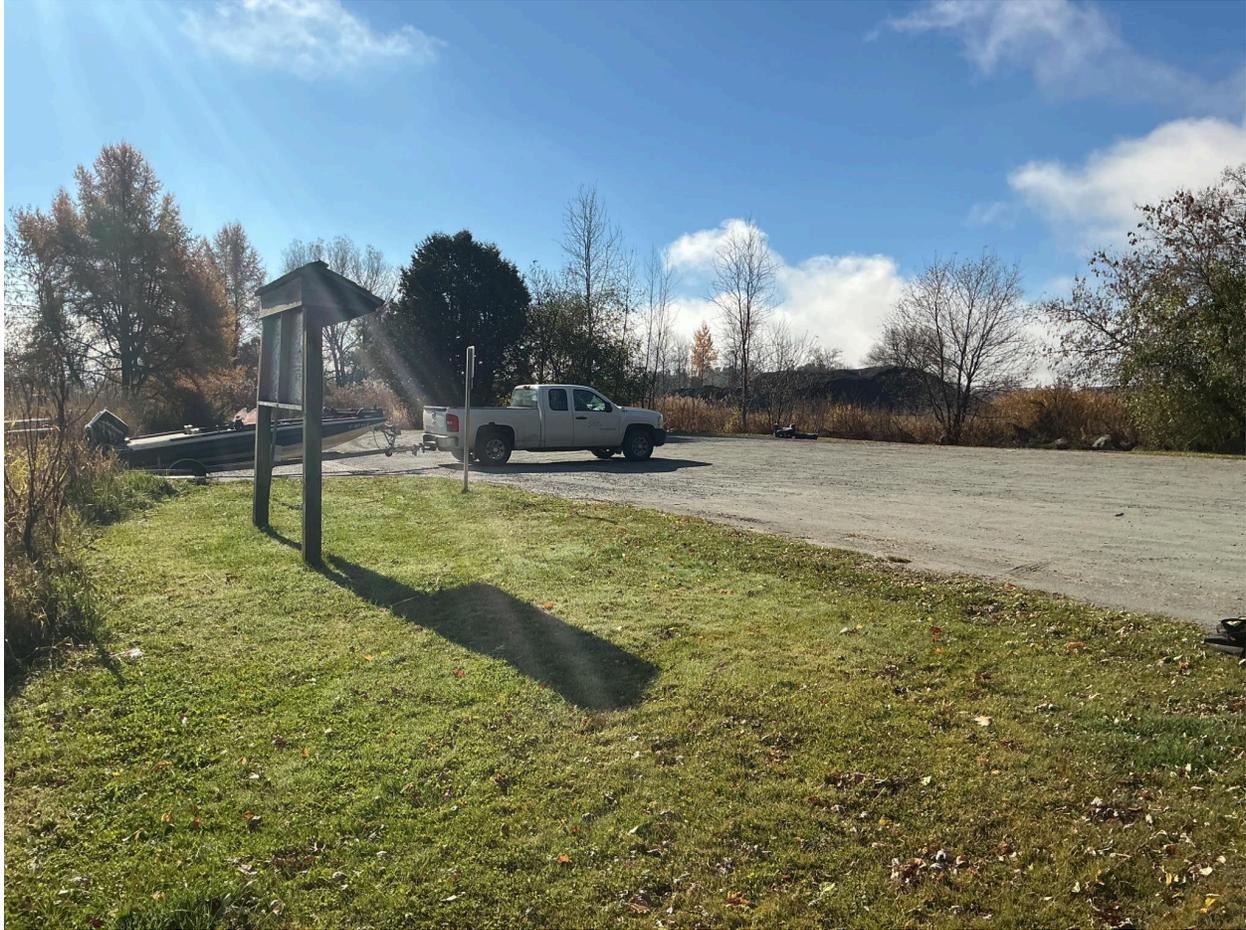
The parking area at South Bay access on Coventry Street is a very large, hard-packed gravel lot with space for well over 30 vehicles with no trailers. The surface is even and easy to traverse. There are no major potholes or obstructions in the parking lot. There is one van accessible handicap designated parking area close to the boat ramp & dock.

Figure 10.) This angle shows only a portion of the very large parking area. Also pictured is the informational kiosk and the start of the motorized boat launch.

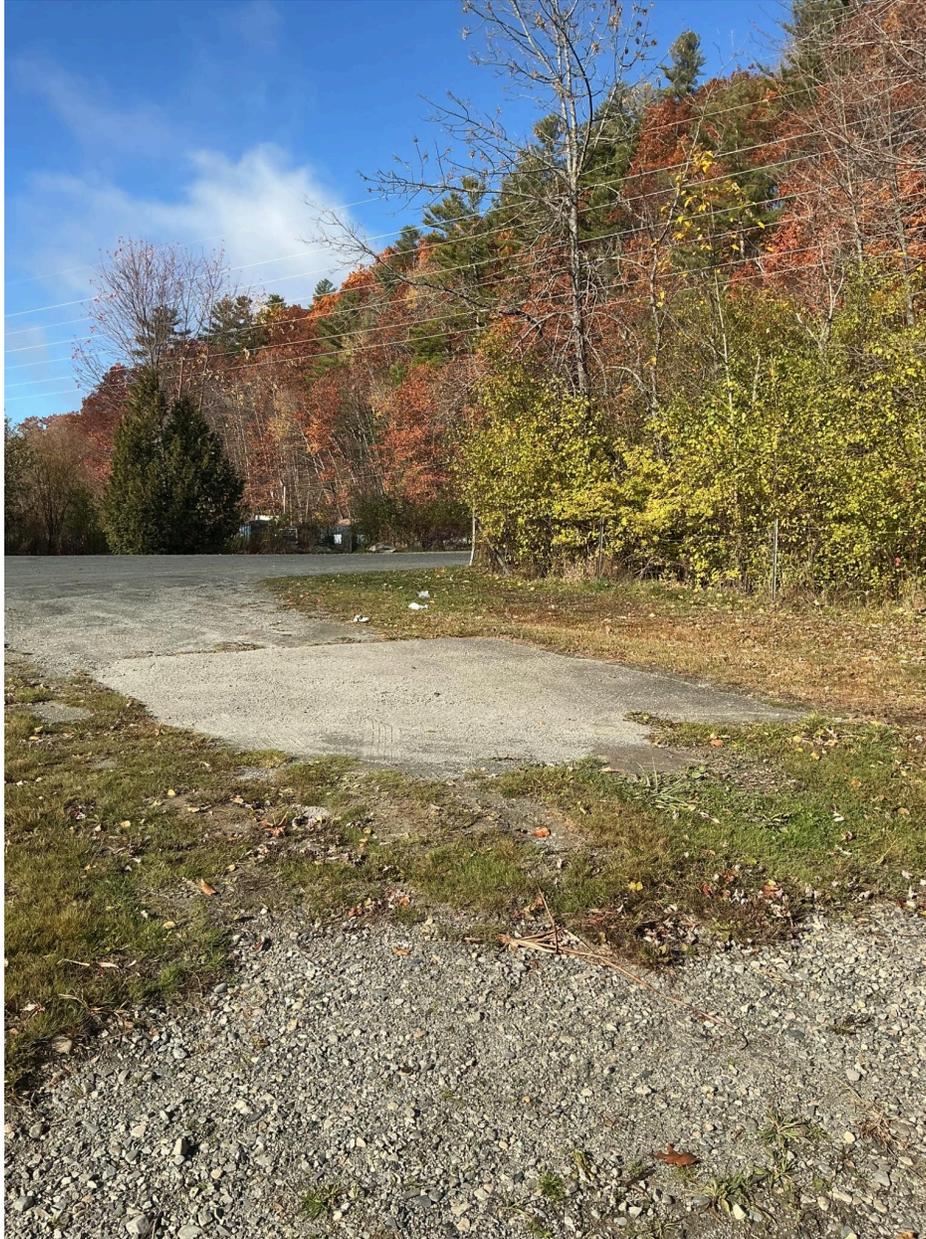
From the designated accessible parking space, it is about 100' to the hand launch ramp via the edge of the parking lot. It is 50' from the parking space to the top of a 50', mixed-surfaced ramp. The pathway to the top of the ramp is even and unobstructed.

Figure 11.) Looking at the access “ramp” to the boat launch. Note the various surface types and changes in grade.

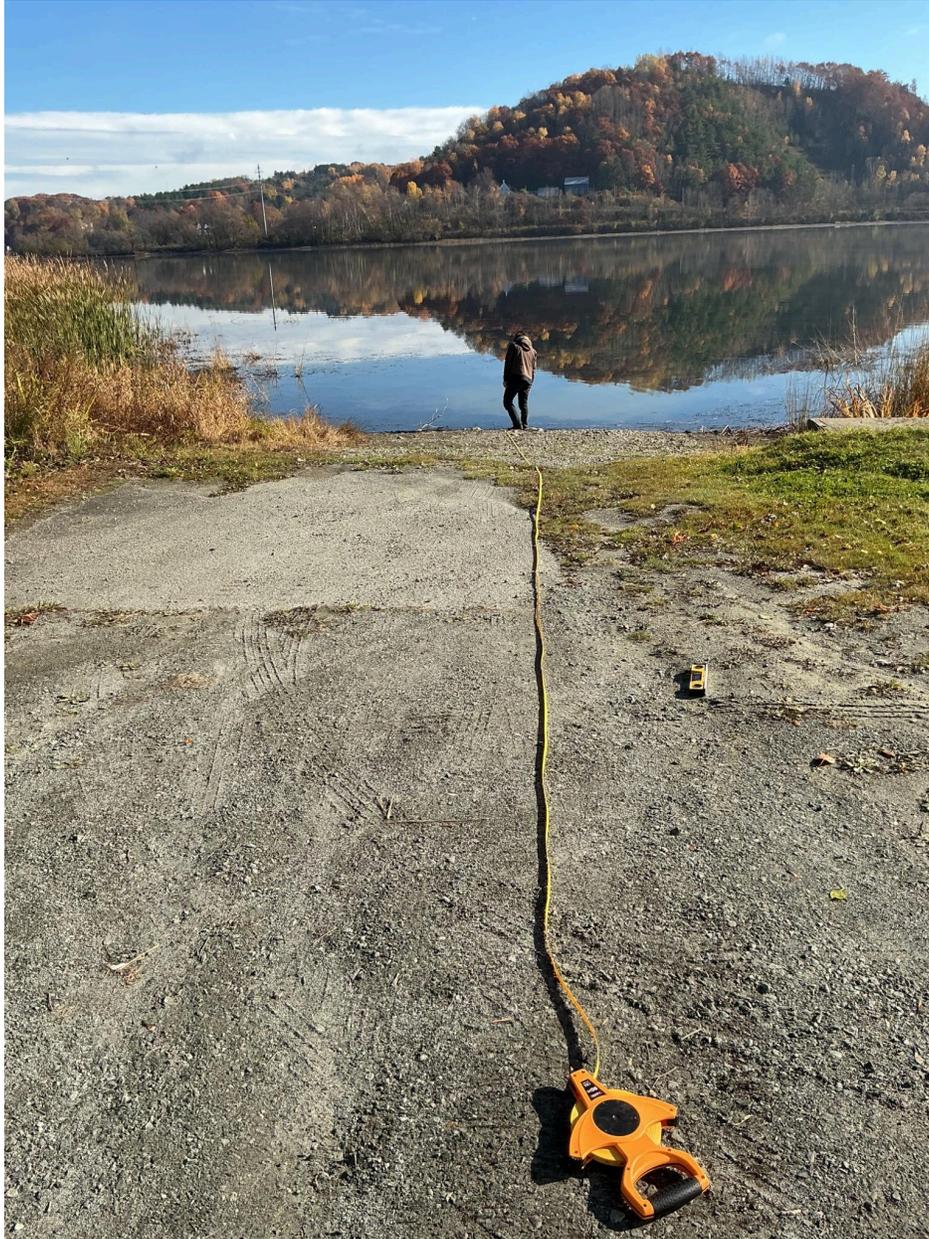
There are 2 access points to the water at this location. A large boat ramp fit for launching power boats, and a smaller hand launch. The large boat launch is about 50' long and 5.4° (10%). The hand launch is 100' from the accessible parking space. The launch area is 12.5' wide and situated in a muddy, marshy section of the bay, and at the bottom of a 50' ramp. The ramp consists of hard-packed gravel, asphalt, some grass and loose packed sandy-gravel at the waterline. The slope of the ramp varies from .92° (1.6%) to 7.9° (14%). The 7.9° grade is due to a slight bump as a result of the concrete pad transitioning to grass and steepening off. There are no large rocks or other obstacles at the launch area.

Figure 12.) Looking down at the water from the top of the access ramp. From the flat surface of the parking lot, it is about 50' to the waterline.

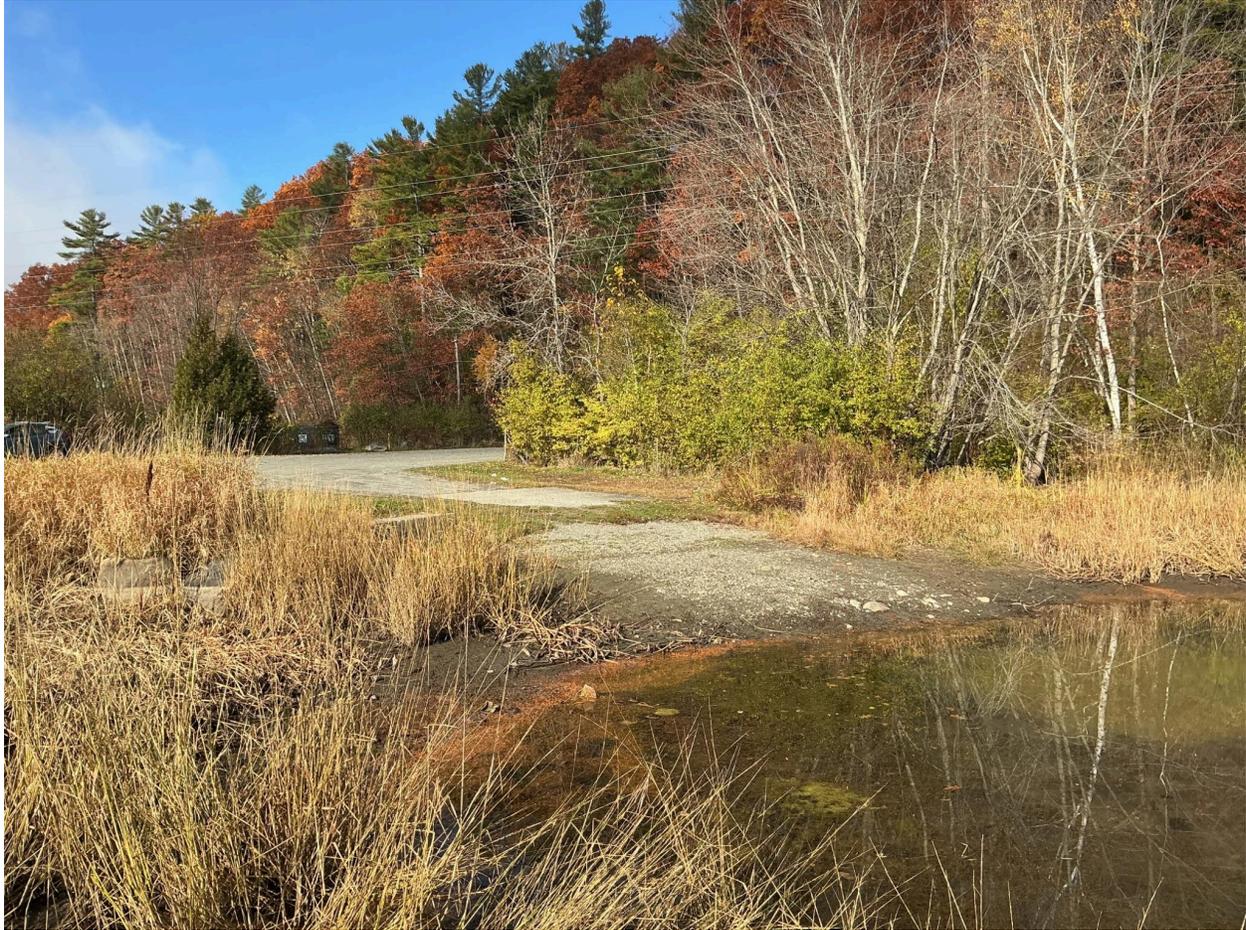
Figure 13.) Looking at the boat launch from the floating dock. The launch area is quite muddy with some algal growth.

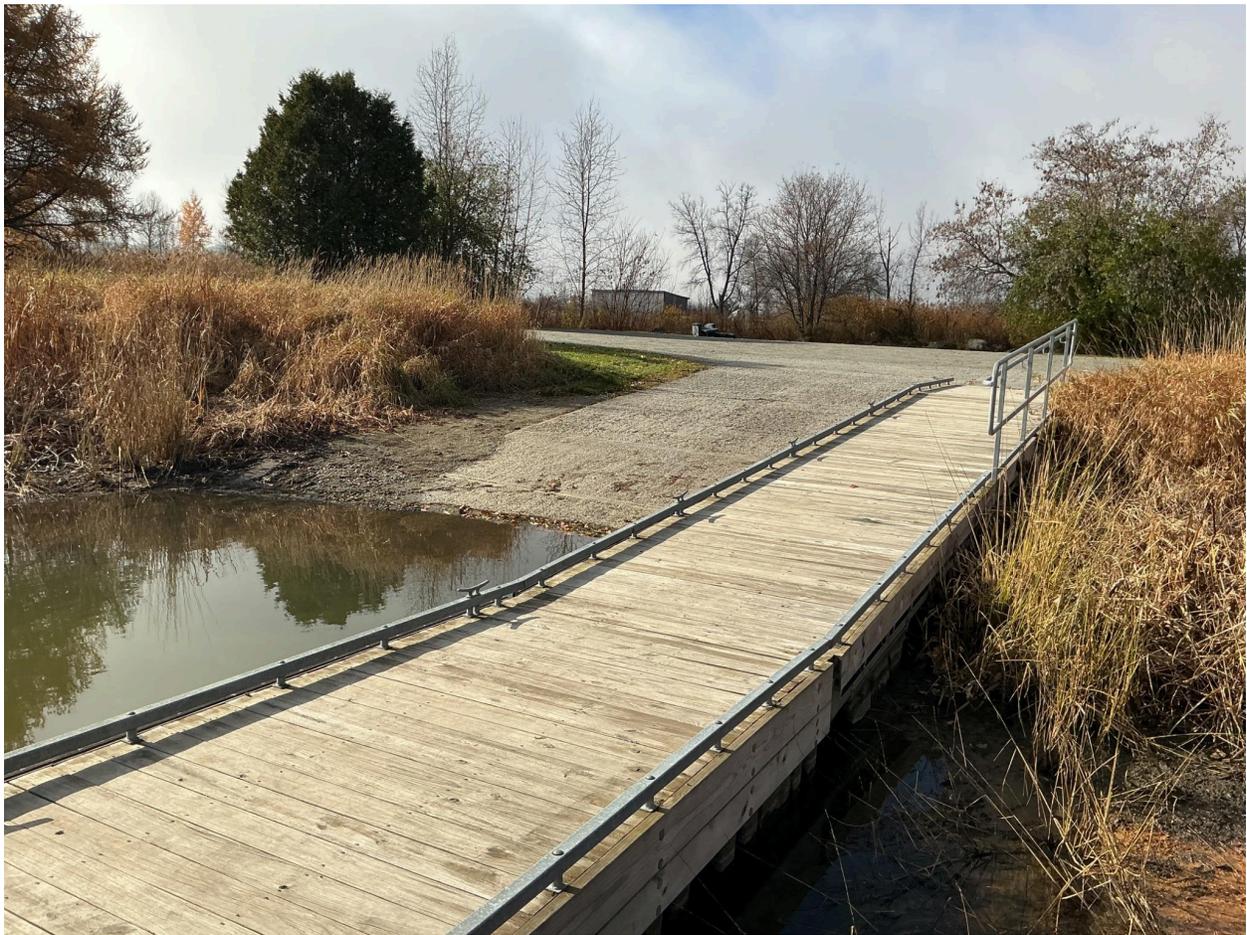
Figure 14.) Looking at the ramp to the floating dock & motorized boat launch.

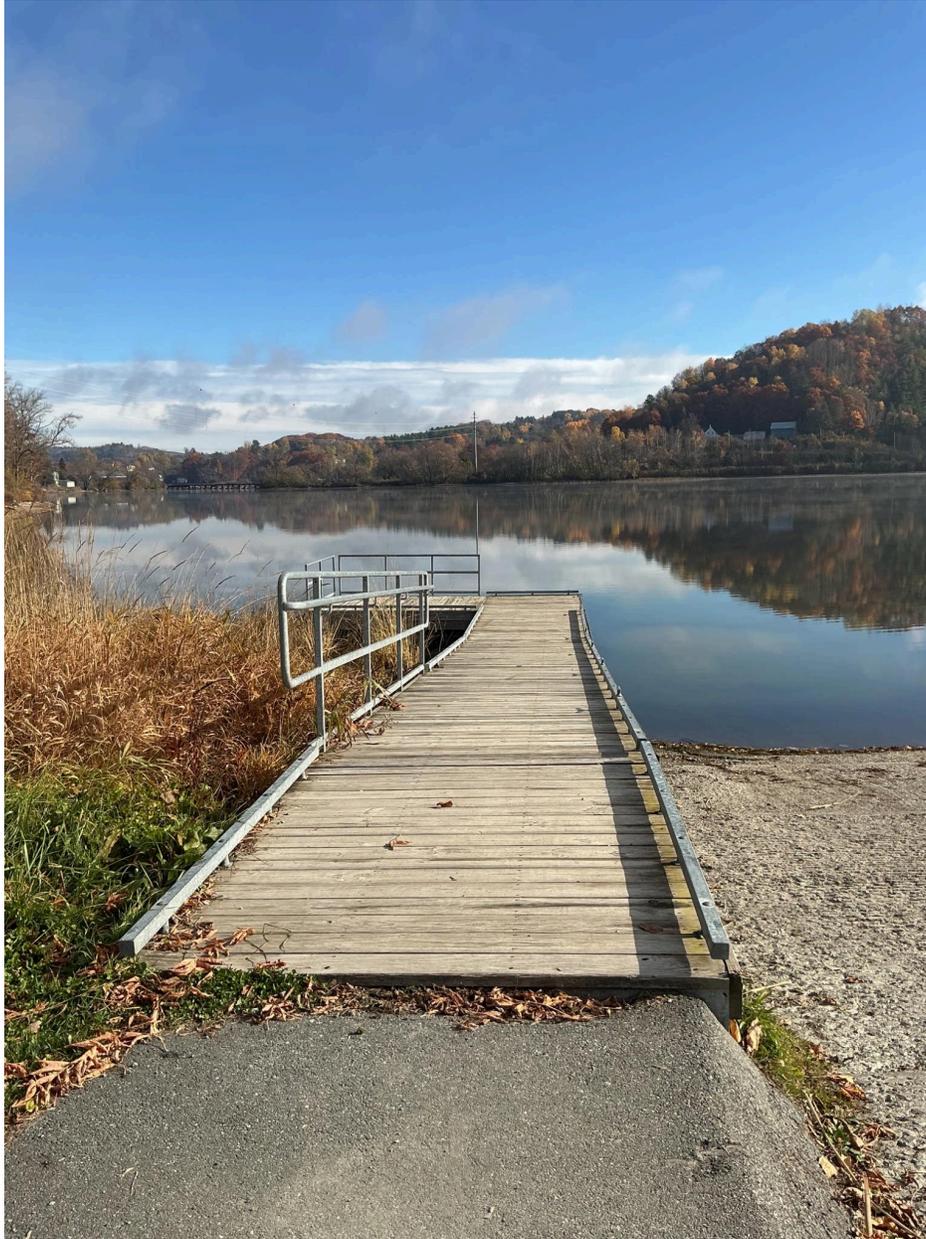
Figure 15.) Looking down the ramp to the floating dock.

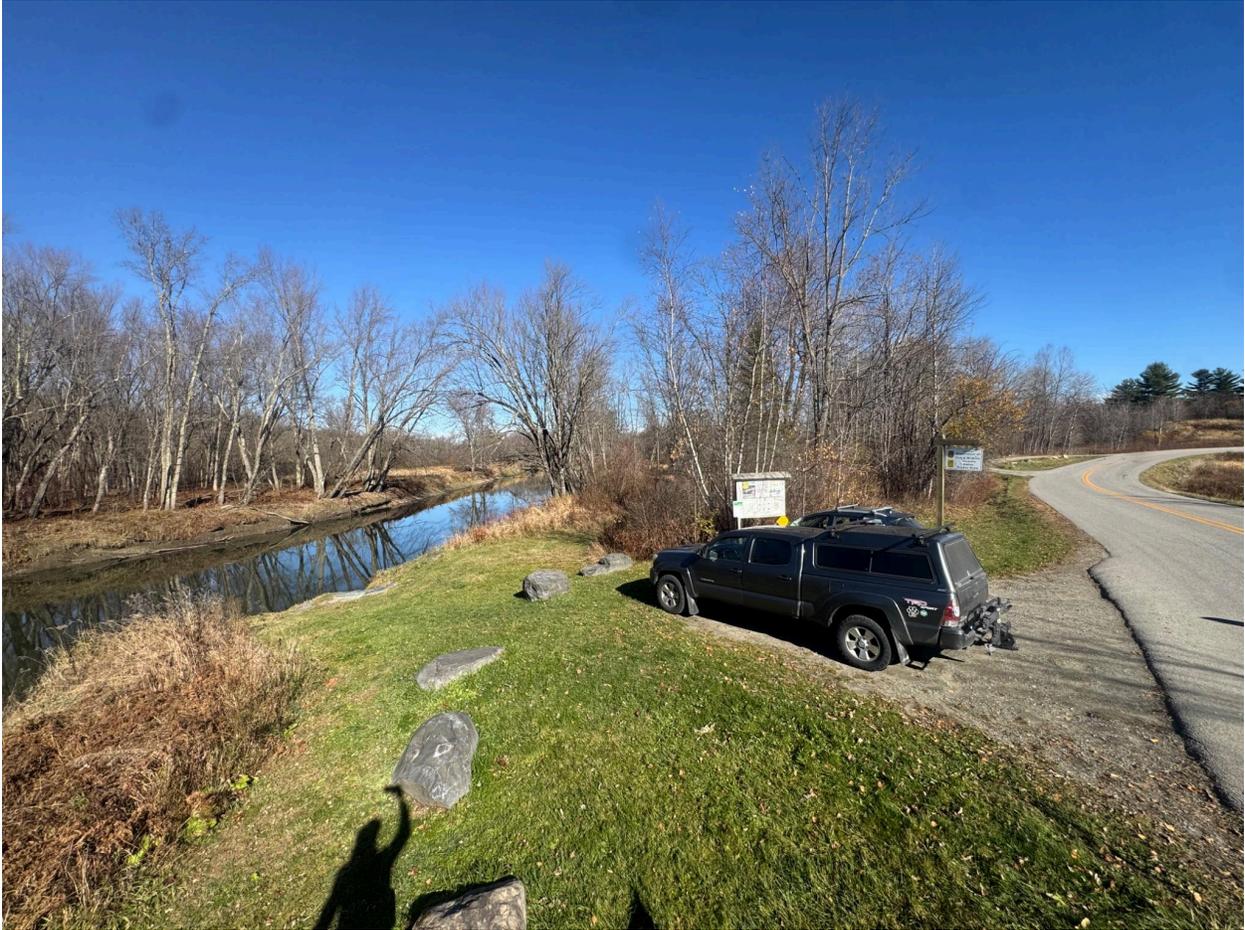
The parking area at Barton River access is a very small, 2 vehicle hard-packed gravel area. The ground is level and has no pot holes. The turn off is immediately after/before a narrow bridge & on a curve in the road. The access is located on a rural road that seems quiet at first but has lots of agricultural traffic. Busy & loud.

Figure 19.) Showing the entirety of the parking area and access to water. Note the close proximity to the road.

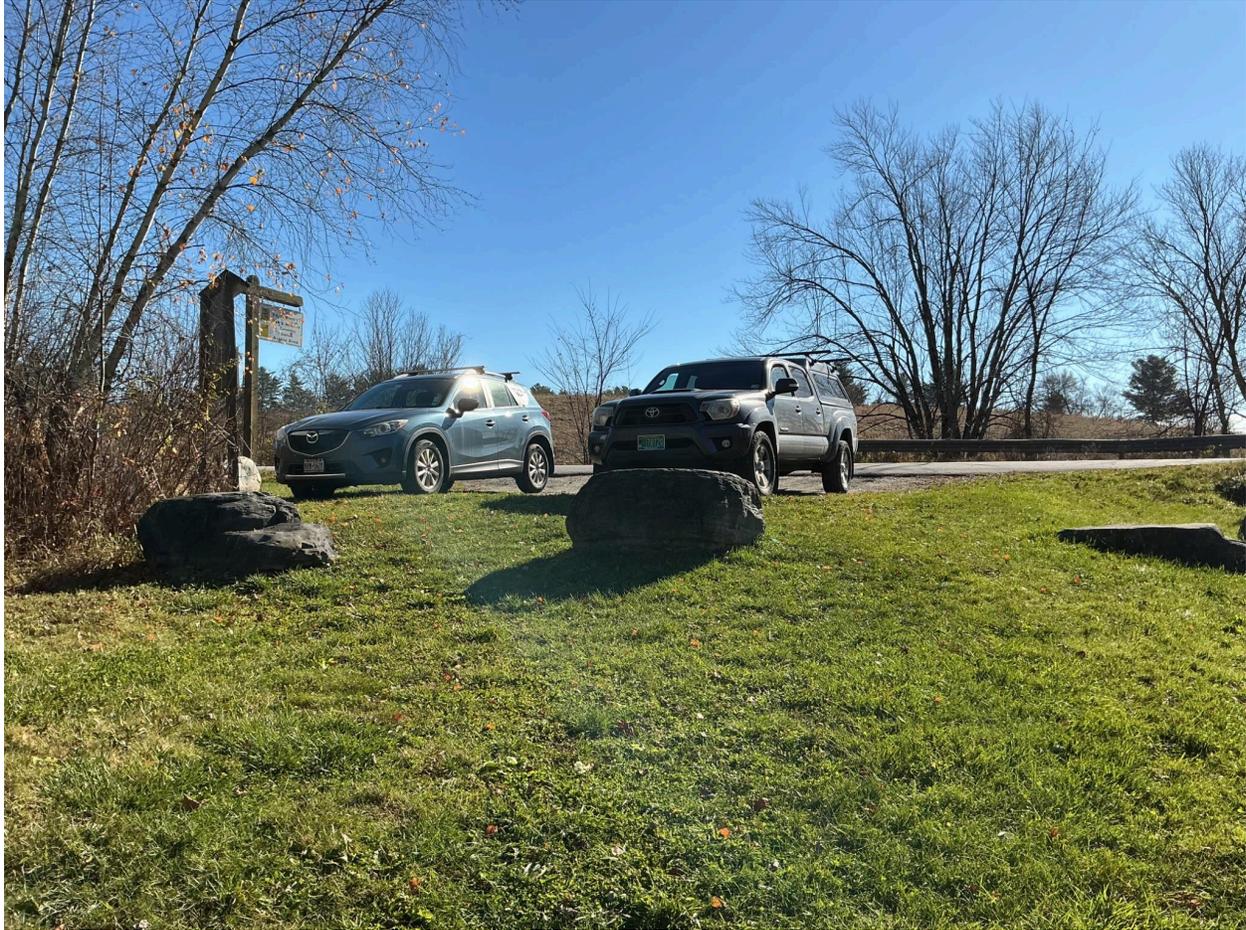
The pathway to the water is a short distance through a small, grassy area. There is no defined trail. The area varies in grade leading to the water from  $5.2^\circ$  (8.8%) to  $8^\circ$  (14%). The grassy slope leads 40' to a set of 7 stone steps going down a steep embankment.

Figure 20.) Looking at the parking area from the top of the set of stone steps.

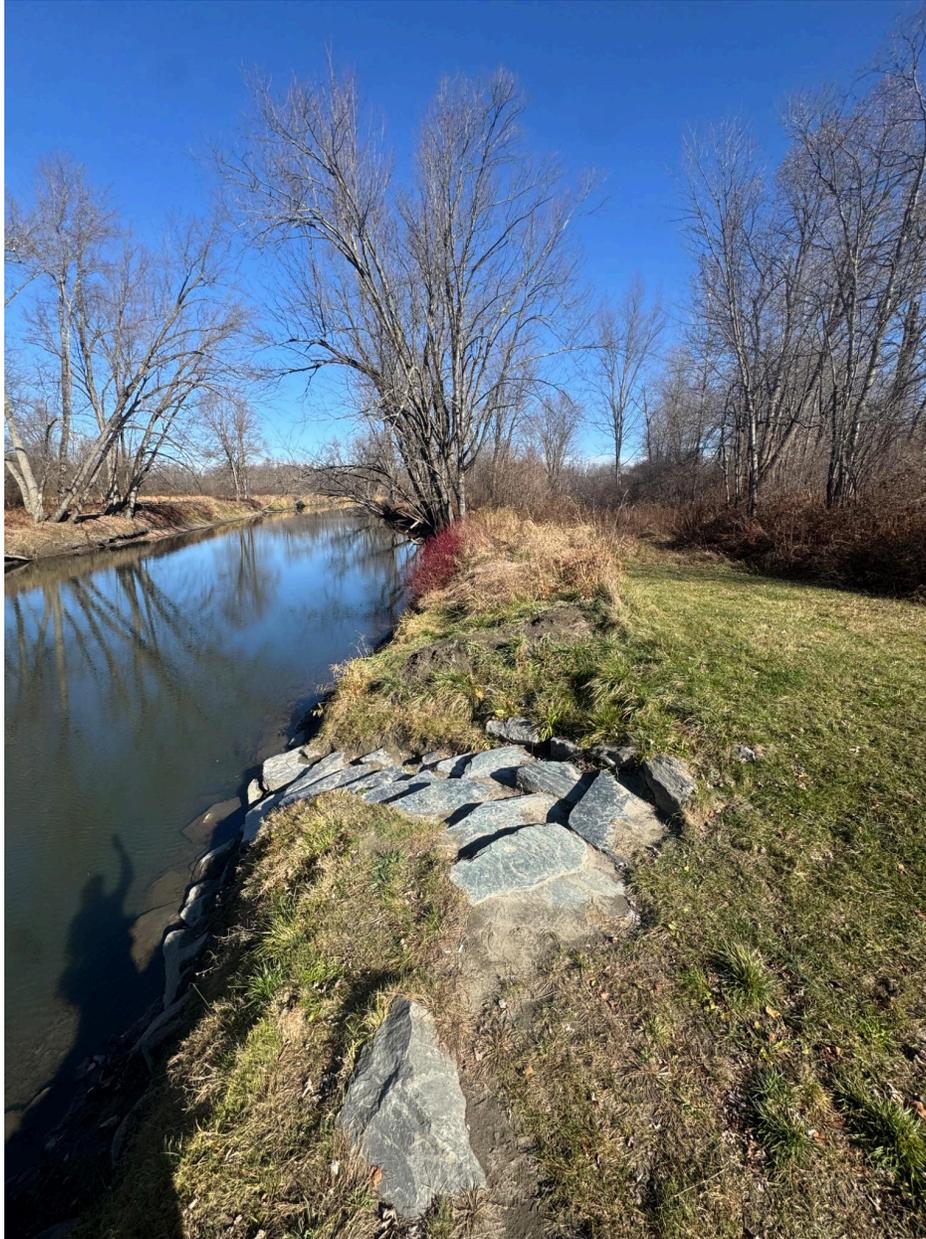
Leading down to the water is a set of 7 stone steps. There is room to launch a canoe parallel to the bank during normal water levels. Some large, submerged boulders below stone steps.

Figure 21.) Showing the stone steps & access to the river.

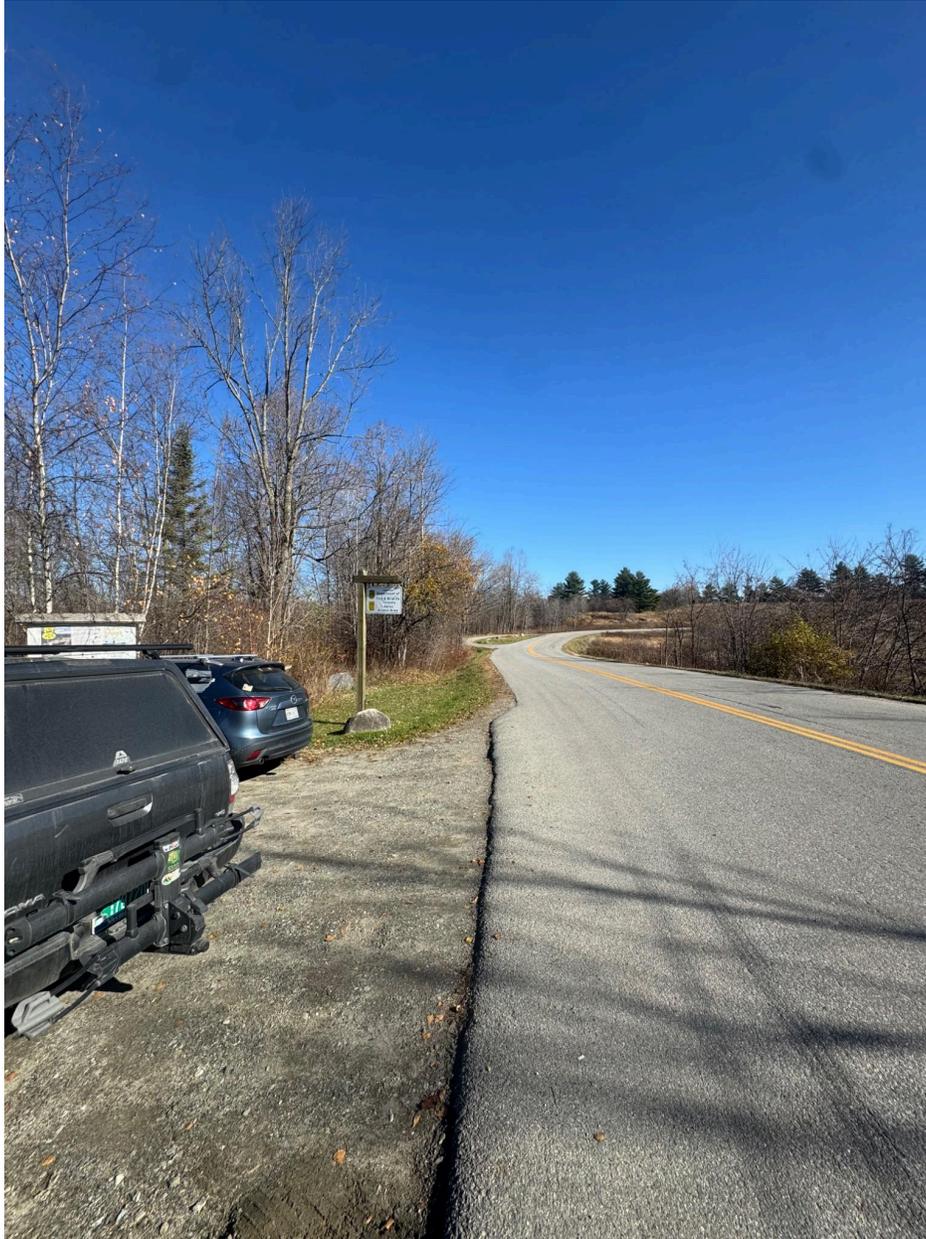
The parking area is situated on a busy road that can be noisy and somewhat dangerous if one is not careful when backing out. The river access is mostly sunny, with some trees nearby to provide shade. There is an informational kiosk. There are about 5 large boulders in the grass near the parking lot. There are no restrooms, tables, benches or other such infrastructure.

Figure 22.) Another angle showing the proximity of the parking area to the main road.

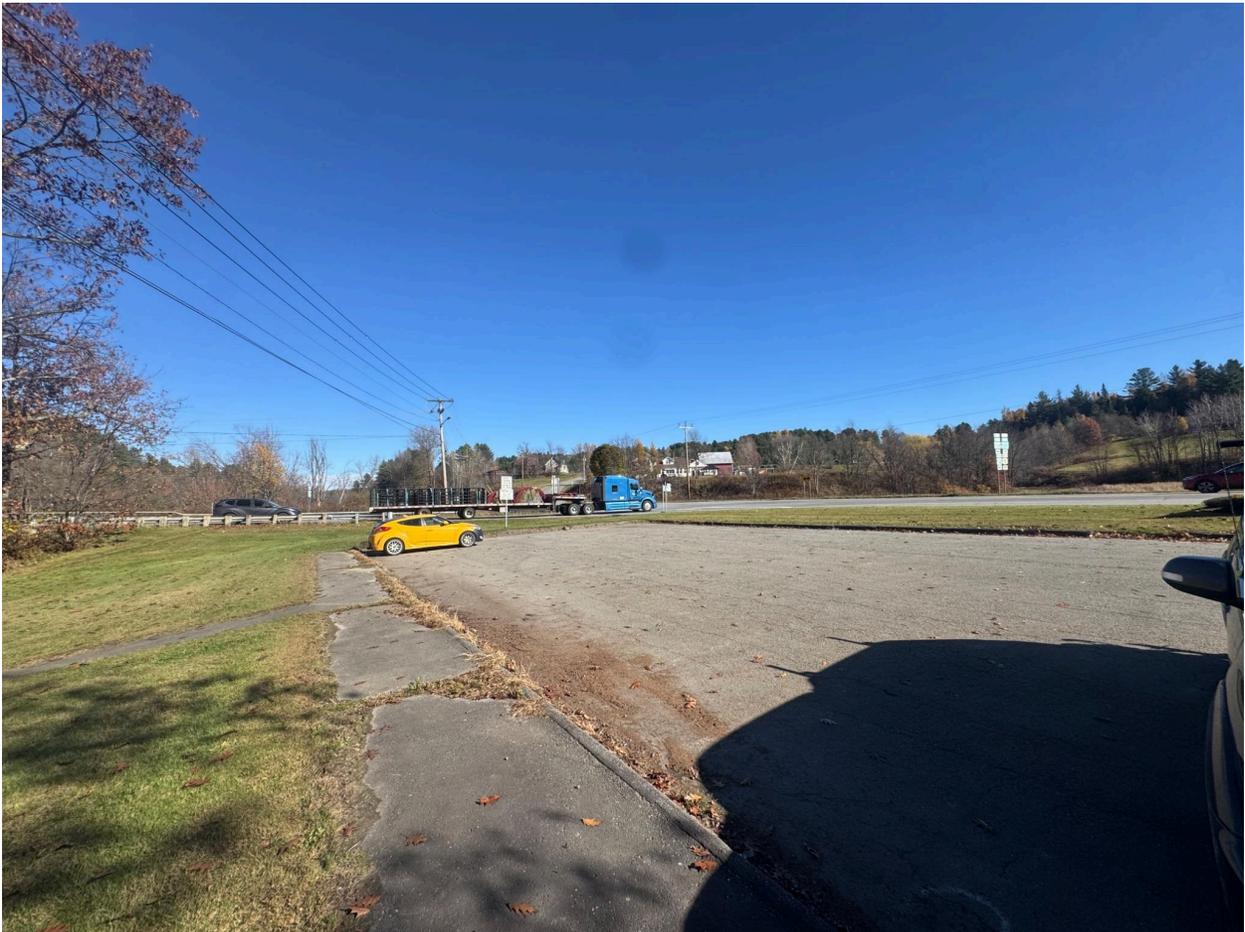
The parking at this area is a large, unkempt, asphalt parking lot. Mostly used as “Park & Ride”. It is located directly off U.S. Route 5. The lot has a curb going around its entirety, apart from the entrance. There are no ramps to access the sidewalk if using a wheelchair. There is lots of vegetation growing out of various cracks. There are no designated handicap parking spaces

Figure 23.) Looking at the parking area from the paved walk way. Notice the many cracks and areas of overgrowth on the sidewalk.

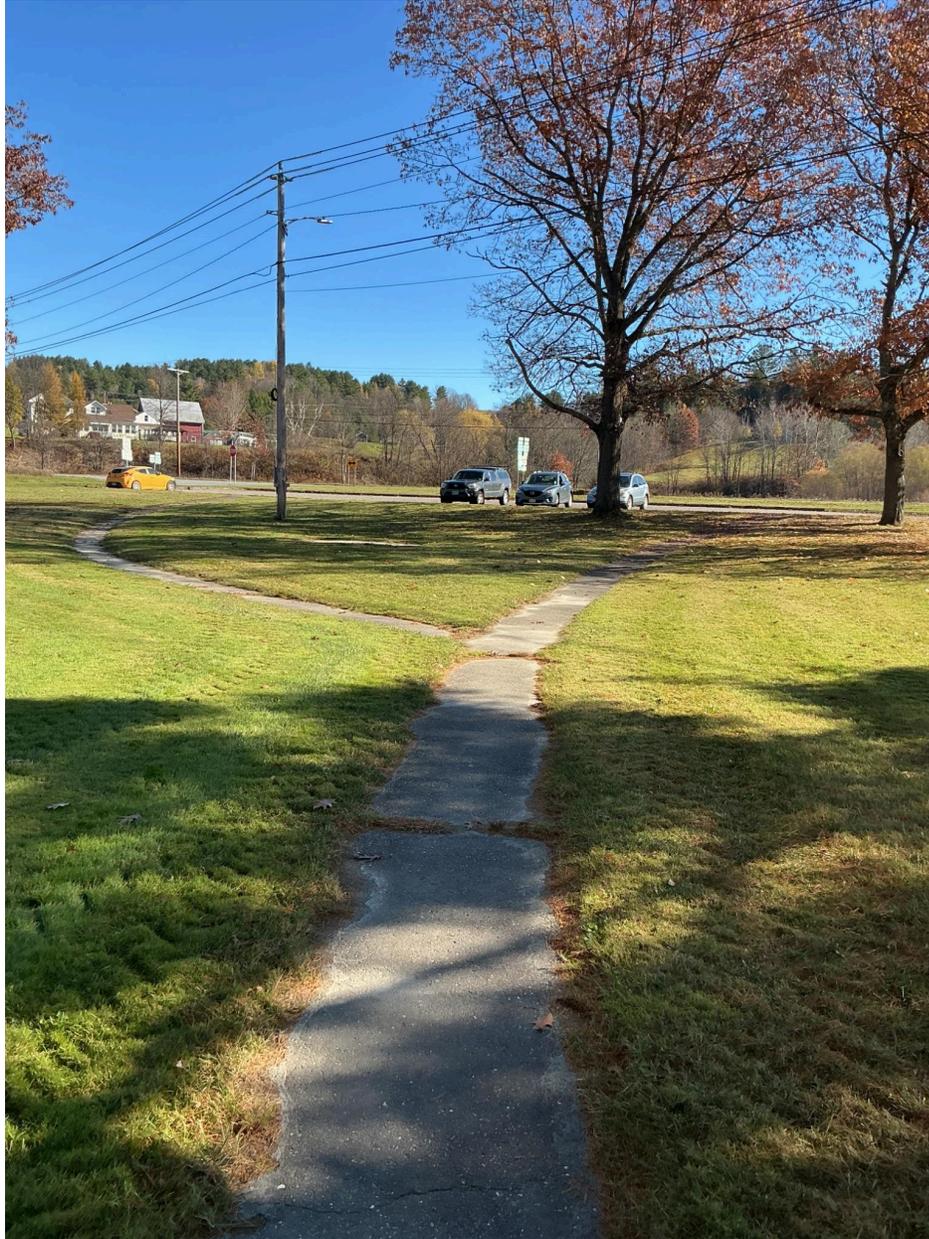
From the parking area there is a long, asphalt pathway that is about 180' long. The pathway is narrow, about 28" wide. Width has been impacted by grass growth. There are cracks in the asphalt. Besides cracks and some bumps, there are no major obstacles heading down the pathway. At the end of the pathway, there is a 31" landscape wall, reinforced with large boulders, that heads toward the river. From the pathway to the water, it is about 50' over the small landscaping wall & down a small embankment.

Figure 24.) Looking at the parking area from the pathway.

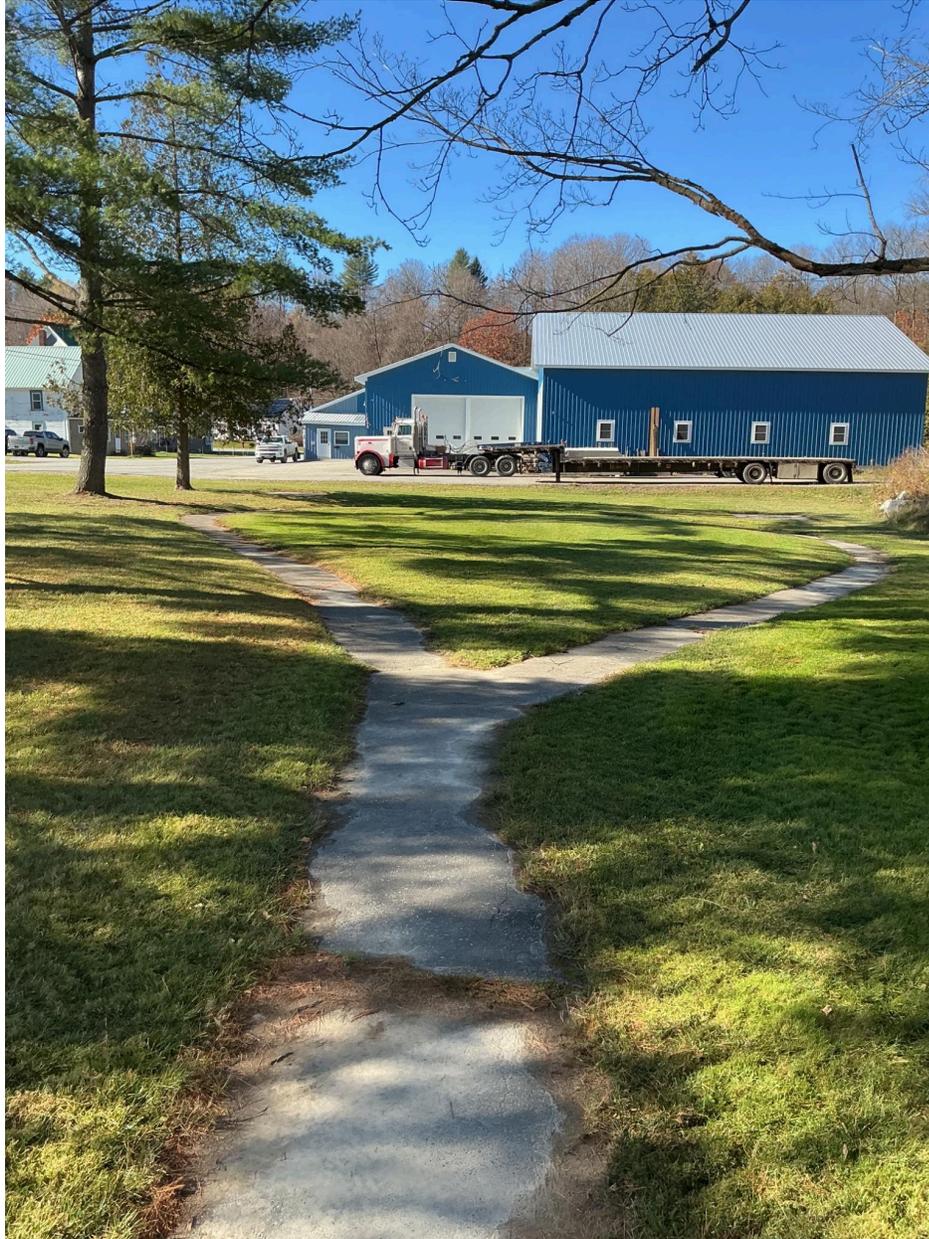
Figure 25.) Looking toward the end of the paved path. Further down the trail on the right-hand side is the river access point

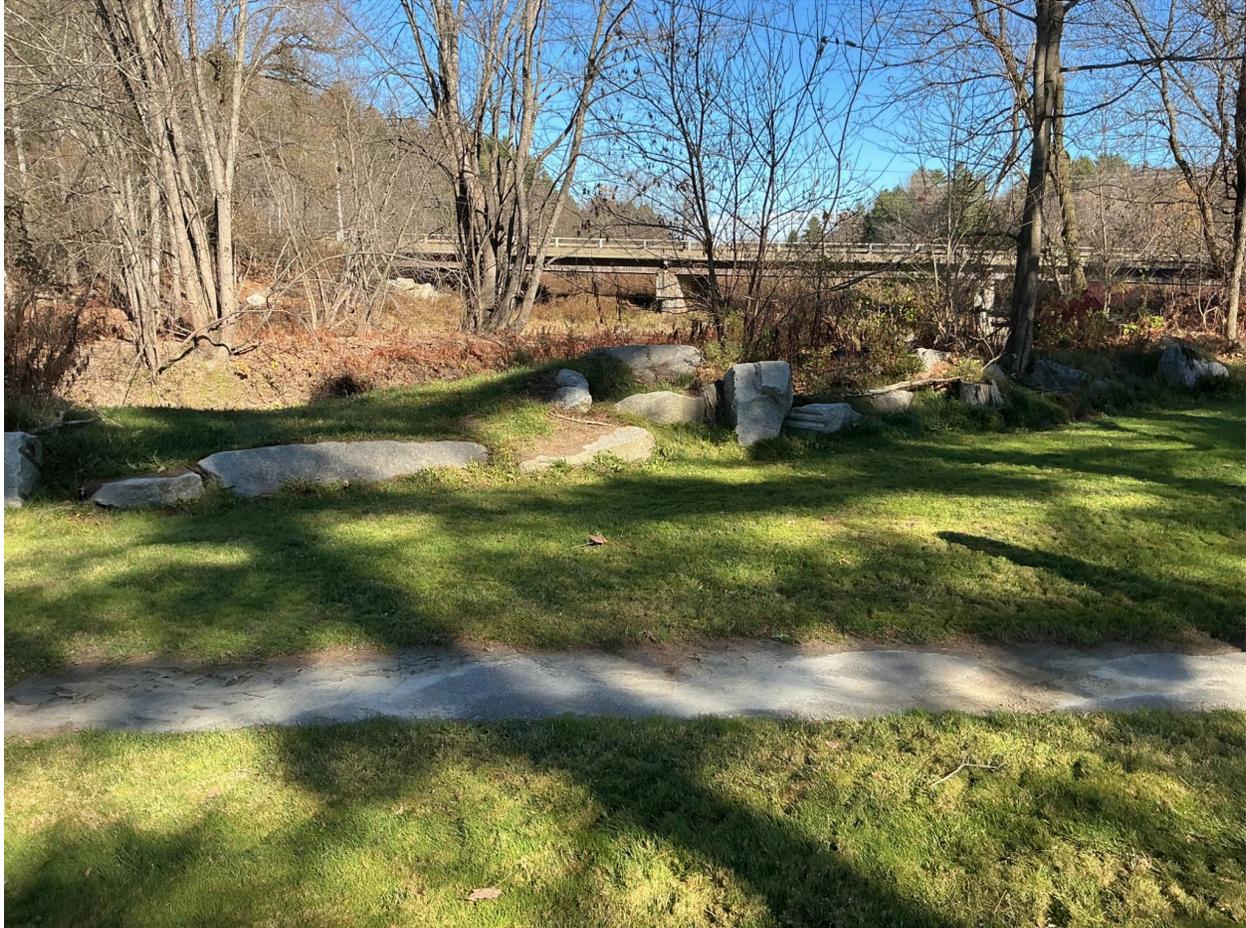
Figure 26.) On the right side of the path, there is a short stone landscaping “wall”. In the grassy area past the long rock on the left is the start of the access ramp.

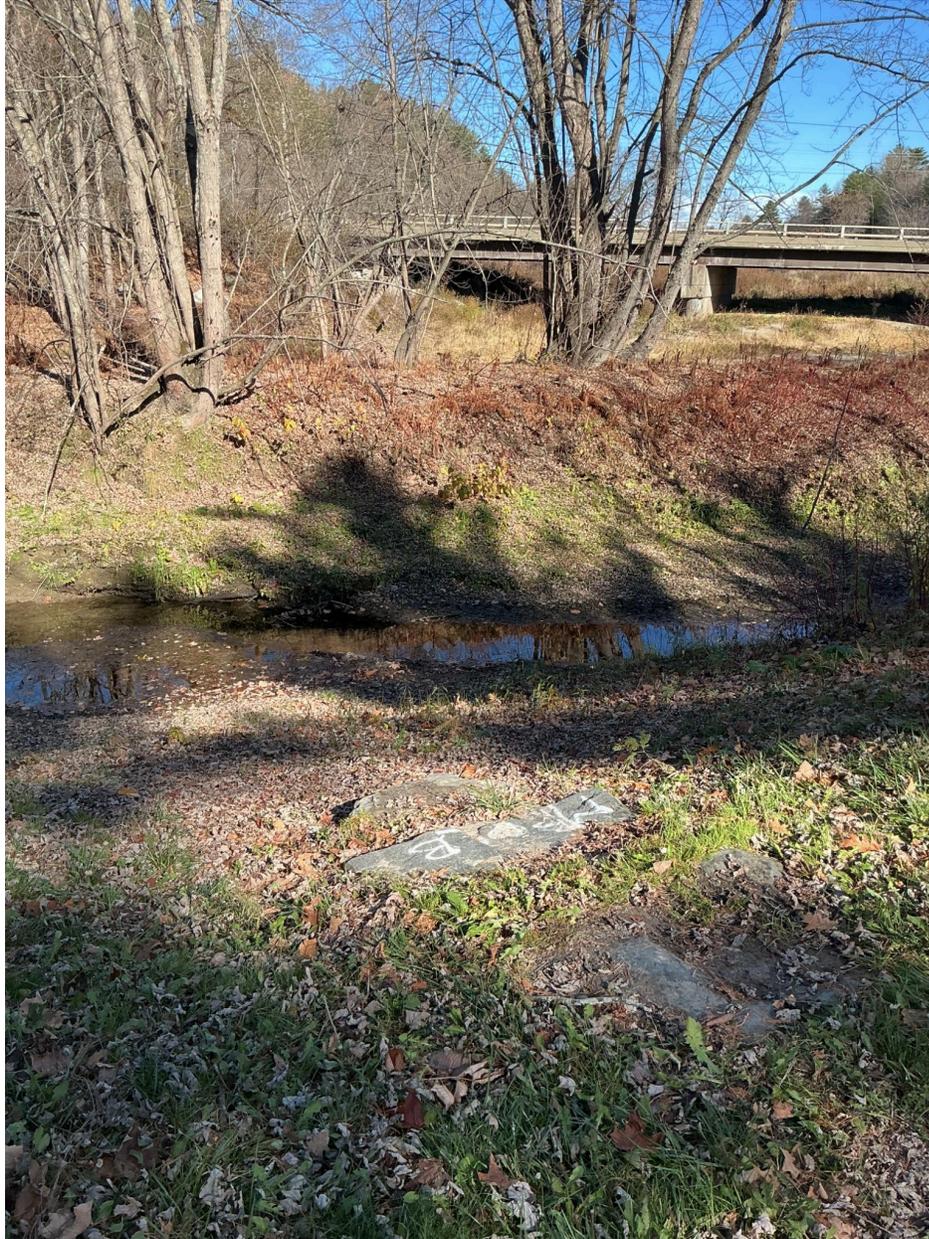
After the 31” landscaping wall, there is a flat grassy patch before it slopes steeply down toward the water. There are 3 large stone steps, then a steep  $15.5^\circ$  (27.8%) slope leading to the water. At the time of the visit there was very little water in the channel, but one could see where it would be possible to launch a canoe. There is enough space to launch a boat parallel to shore. The current surface at the water was made of mud and small vegetation.

Figure 27.) Looking down to the water from the top of the access ramp. Notice the almost completely overgrown “steps” as well as the incredibly low water conditions. Launching in such conditions is not advised.

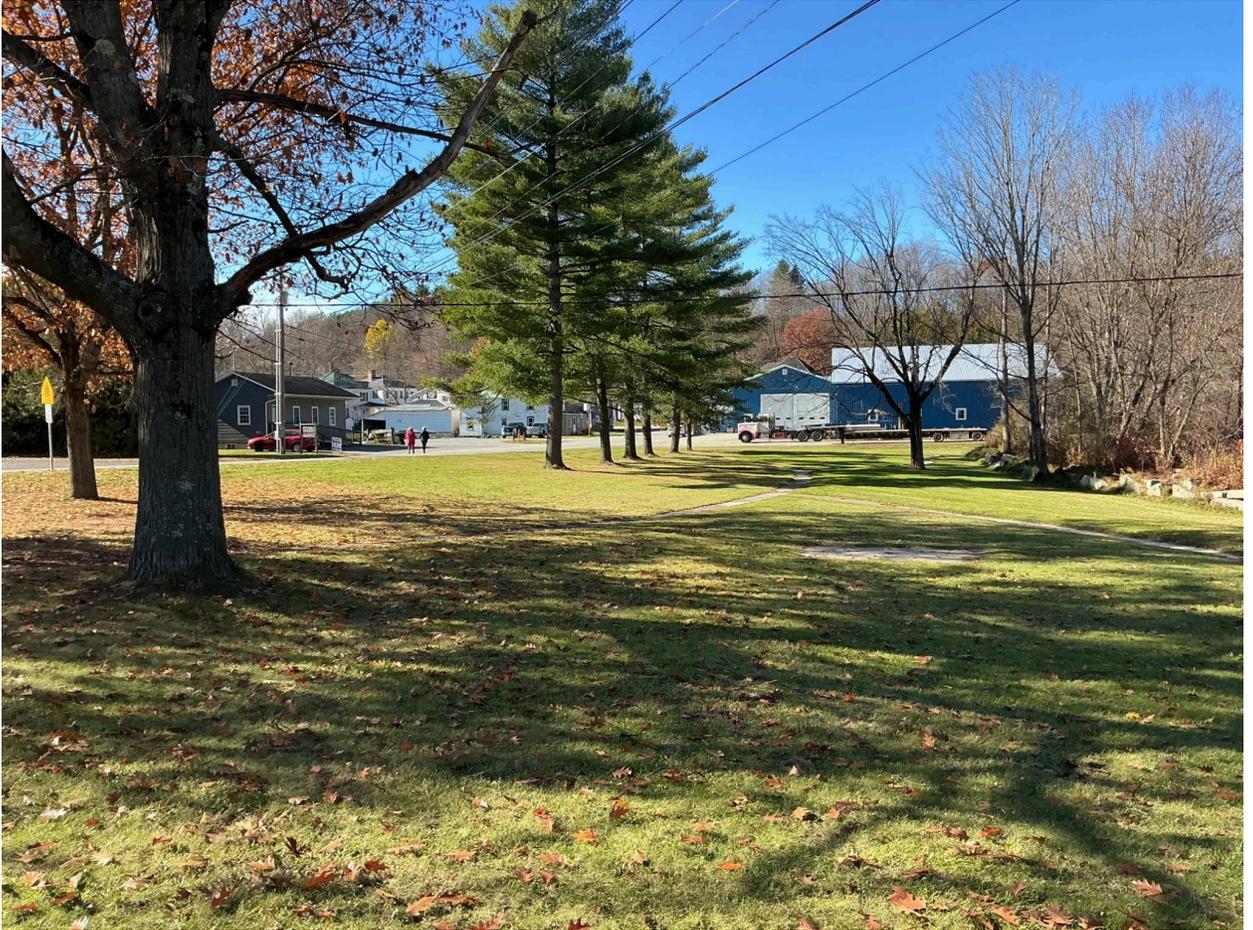
Figure 28.) Looking from the parking lot down the long pathway to the water access.
