## Missisquoi National Wildlife Refuge

[Missisquoi Wildlife Wonders](#) trip description

[Louie's Landing](#) (44.958362, -73.166263)

### **Site 3. Sandy Point/Larry Green Access (44.970524, -73.211101)**

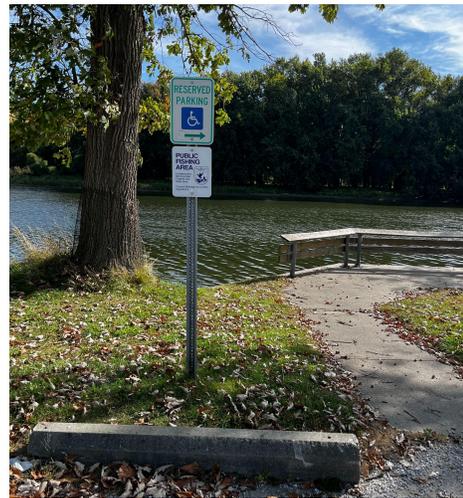
Figure 2. accessible parking space

Parking – Parking area is flat and wide, half pavement and half gravel. Two designated accessible parking spaces, at least one on both sections (Figures 1 & 2). Room for parking and turning around a trailer.

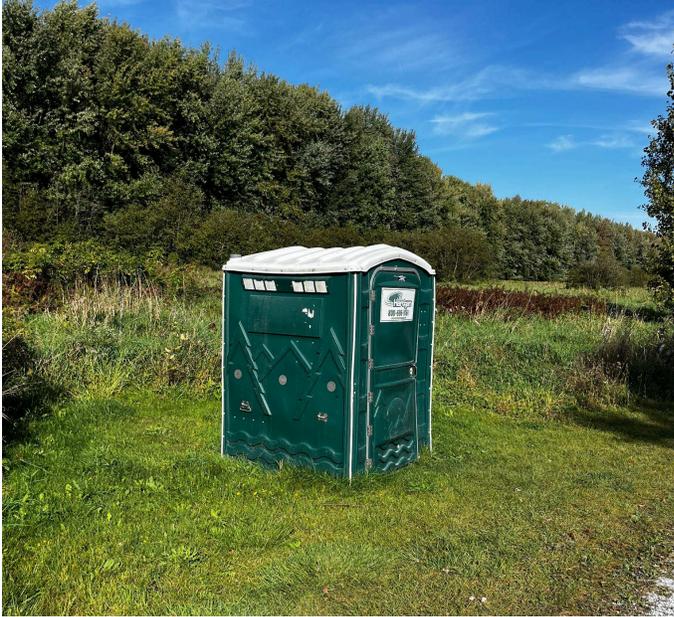
Figure 3. Portable toilet at Mac's Bend

Bathroom – There is no bathroom at Louie's Landing, but there is one a short walk away at Mac's Bend (~400-500' down a trail/road that starts as grass then transitions to gravel). There's a gate at Louie's Landing that is only open from September to December. When that gate is closed, there's a 46" wide gap to get through and access the trail. Restrooms also available at visitor's center down the road.

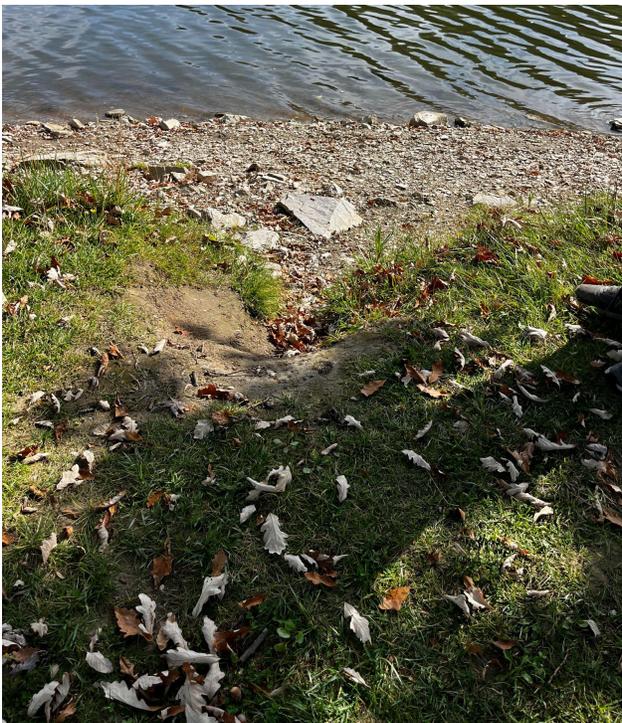
Figure 4. Informal trail to water

Trail to Water – ~85 feet from parking area to water's edge with reasonable grades. Not really a "trail", just a flat, paved parking lot. Some informal trails leading down to the water as well with steep with loose gravel and dirt (Figure 4.)

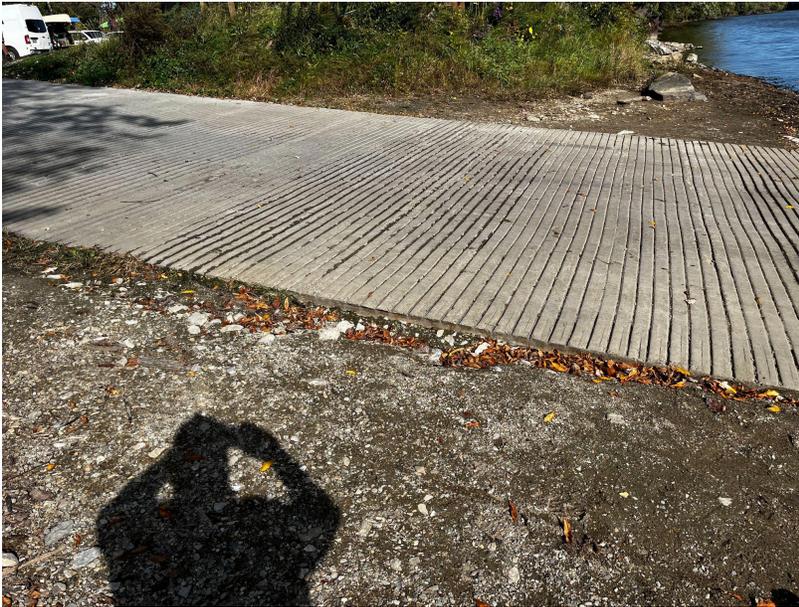
Figure 5. Boat ramp

Water Access – A 53-foot concrete boat ramp with a slope of less than 5% provides a generally accessible entry point. There are a handful of other informal access points leading down to the water that were established by people scrambling down the bank. They are somewhat steep, with loose rock and dirt so not very safe.

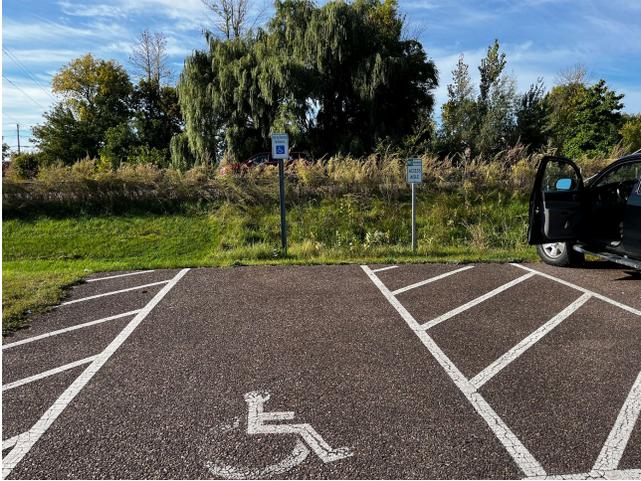
Figure 11. Accessible parking space

Parking – Paved parking lot with one signed accessible parking spot. Tons of space in the lot, sufficient for turning around and parking trailers. There is a signed "Accessible Aisle" next to the spaces for loading and unloading.

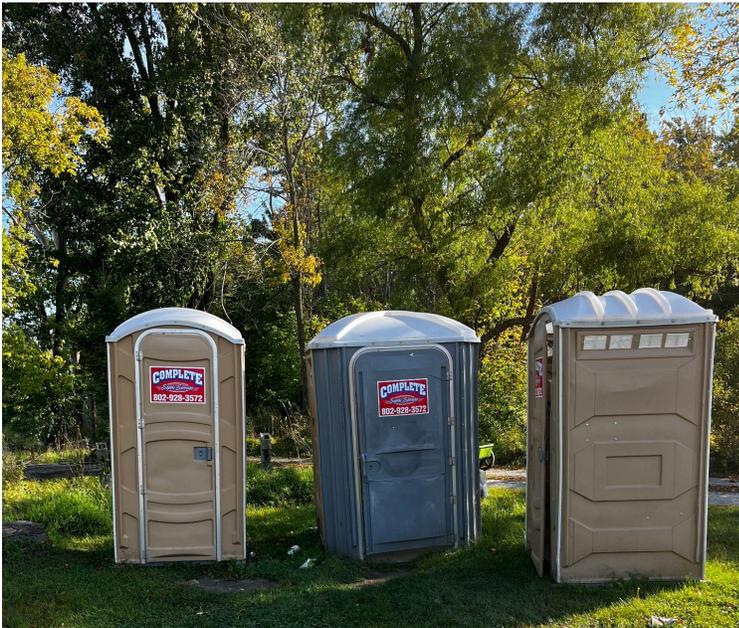
Figure 13. Porta-potties

Bathrooms – Three total restrooms, one of which is accessible. They are located in the parking area, roughly ~200' from the water's edge.

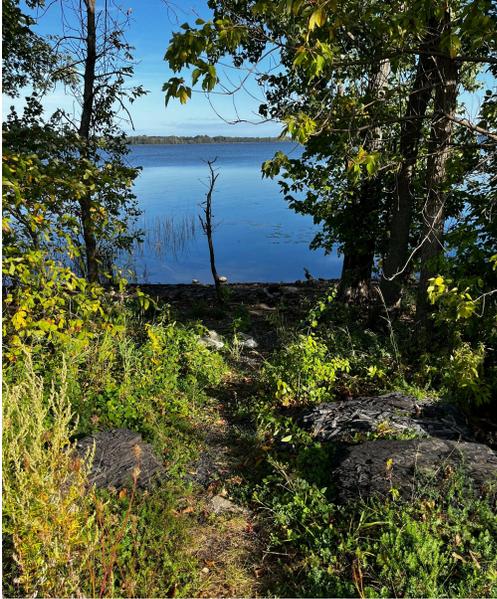
Figure 14. Informal Trail

Trail to Water – The main water access is a concrete boat ramp leading directly from the parking lot, but there’s also another informal trail leading through the woods over to the water. Gravel trail leading to a stone-filled beach.

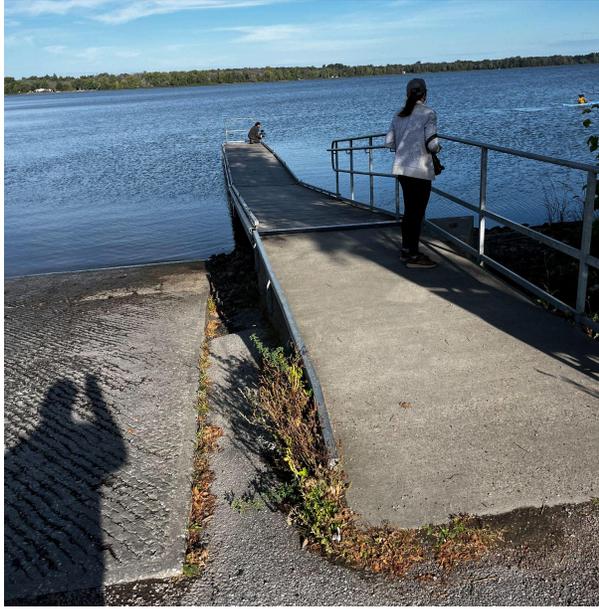
Figure 15. Dock

Water Access – The concrete boat ramp is 30’ long and very wide, with room for launching multiple boats at once. It has a ~11% grade and the concrete is grooved. There’s a dock next to it, which is 40’ long and wobbly. There’s a large gravel beach to the left of the ramp with some scattered debris.
